Company Name: Cricklade Road Management Company Limited

Inspector Name: Thomas Dellow MIRPM

Inspection Date: 26 October 2023

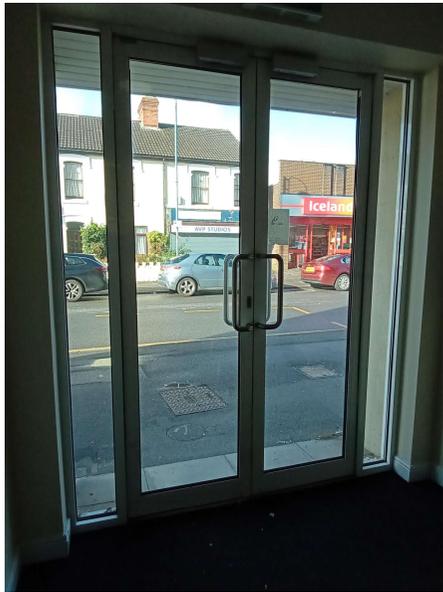
Entrances (Main Doors)

| Internal Inspection | Acceptable | Not Acceptable | N/A | Comments | Action |
|--|---|---|---|--|---|
| Entrances (Main doors) | ✓ | | | The main entrance doors and vehicle gate were secure and accessible. | None |

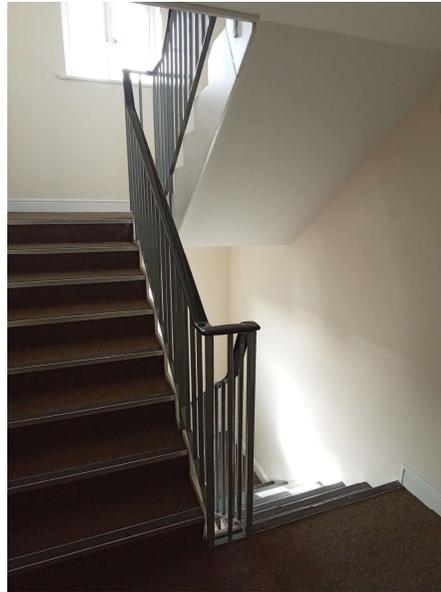
| Internal Inspection | Acceptable | Not Acceptable | N/A | Comments | Action |
|--|---|---|---|--|---|
| Hallway (Communal Lobbies and Stairs) | ✓ | | | The communal hallways and lobbies were clear and accessible. | None |

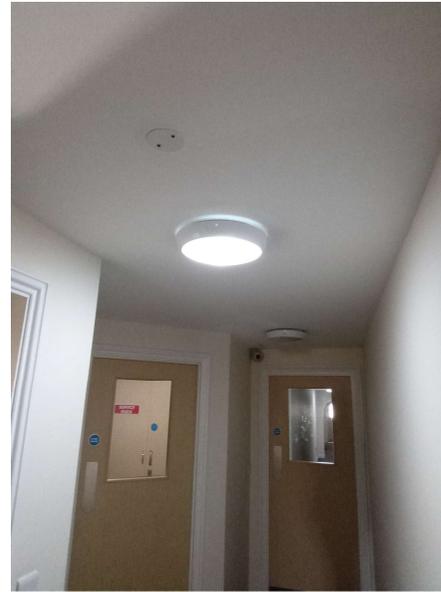
Lighting (Standard and Emergency Lights)

| Internal Inspection | Acceptable | Not Acceptable | N/A | Comments | Action |
|--|---|---|---|--|---|
| Lighting (Standard and Emergency Lighting) | ✓ | | | The emergency lighting was tested with satisfactory results. | None |

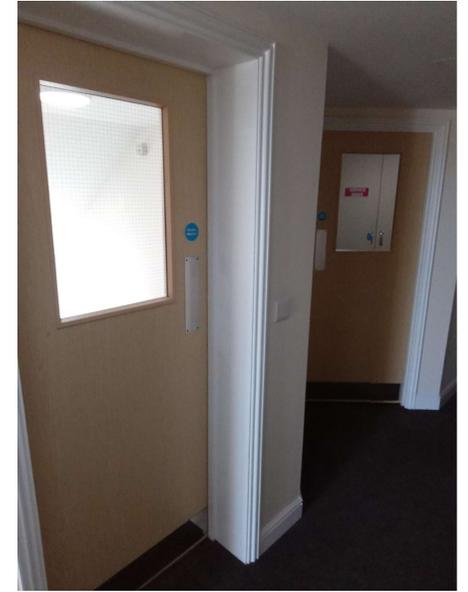
| Internal Inspection | Acceptable | Not Acceptable | N/A | Comments | Action |
|--|---|---|---|--|---|
| Internal Doors (Compartment Doors) | ✓ | | | The internal compartmenting doors appear in good visual condition. | None |

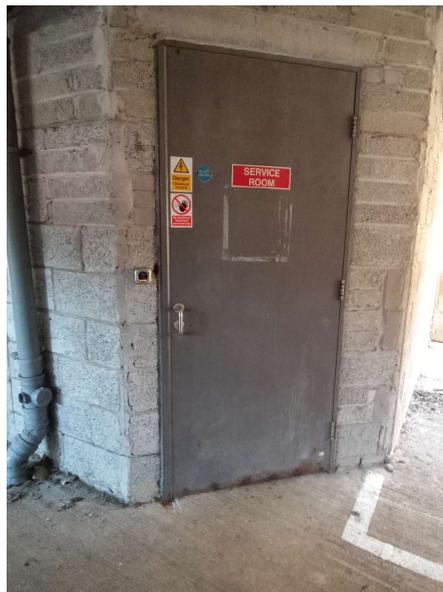
| Internal Inspection | Acceptable | Not Acceptable | N/A | Comments | Action |
|--|---|---|---|--|---|
| Cupboard Doors (Electrical Cupboard Doors) | ✓ | | | The cupboard doors were secure. | None |

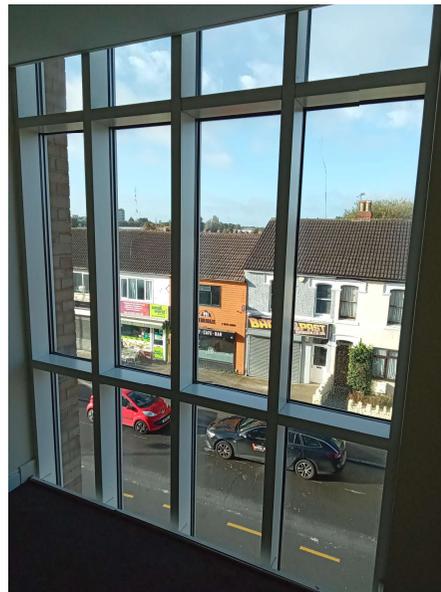
| Internal Inspection | Acceptable | Not Acceptable | N/A | Comments | Action |
|--|---|---|---|--|---|
| Windows (Communal Windows) | ✓ | | | The communal windows appear in good visual condition. | None |

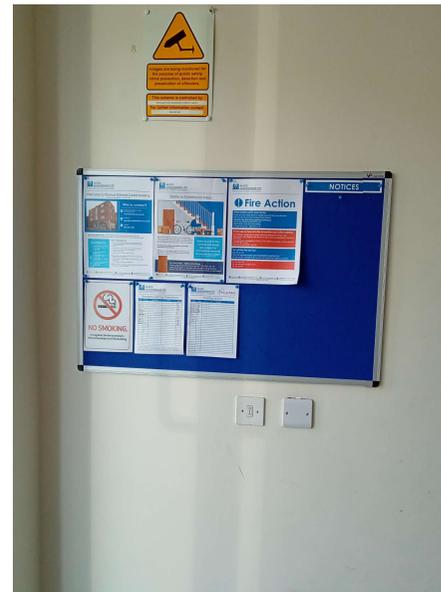
| Internal Inspection | Acceptable | Not Acceptable | N/A | Comments | Action |
|--|---|---|---|--|---|
| Signage (Communal Notices) | ✓ | | | Signage is present and up to date. | None |

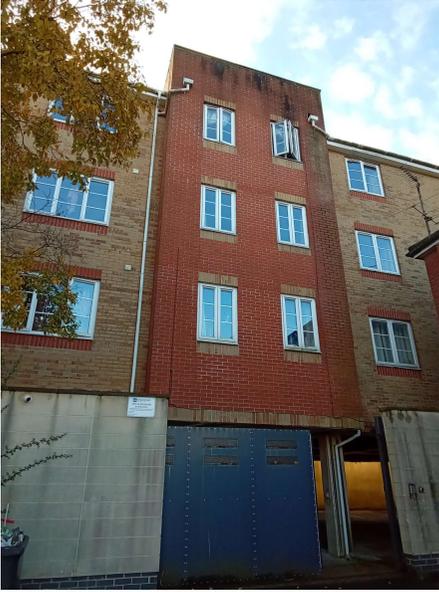
| External Inspection | Acceptable | Not Acceptable | N/A | Comments | Action |
|---|---|---|---|--|---|
| Exterior Structure (The Building) | ✓ | | | The exterior structure appears in good visual condition. Consideration could be given to soft washing the walls. | Review |

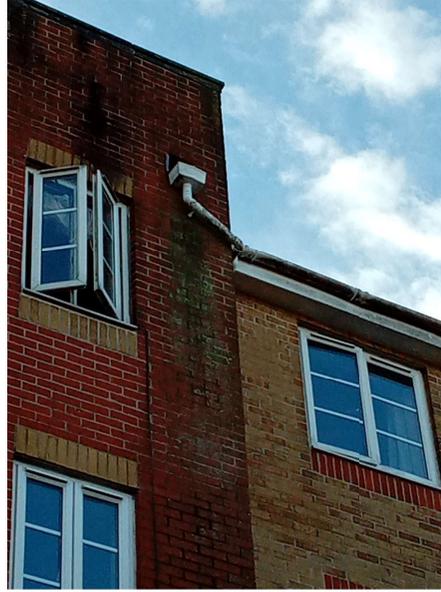
| External Inspection | Acceptable | Not Acceptable | N/A | Comments | Action |
|---|---|---|---|--|---|
| Guttering (Gutters and Fascia) | ✓ | | | The guttering appears in good visual condition, consideration could be given to clearing the gutters and downpipes. | Review |

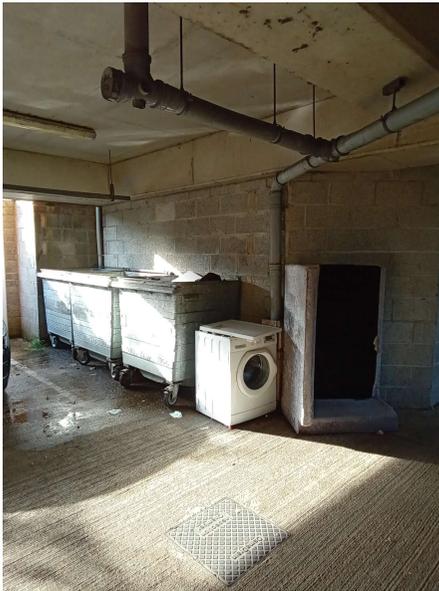
Bin Store (Waste Disposal Area)

| External Inspection | Acceptable | Not Acceptable | N/A | Comments | Action |
|---|---|---|---|--|---|
| Bin Store (Waste Disposal Areas) | | ✓ | | The bin store was tidy however there are fly-tipped items next to the eurobins. The fly-tipper will be identified and asked to remove the waste. | Review |

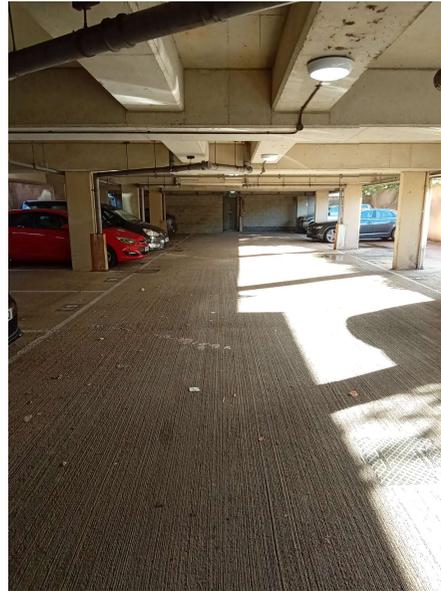
| External Inspection | Acceptable | Not Acceptable | N/A | Comments | Action |
|---|---|---|---|--|---|
| Car Park (Vehicle Parking) | ✓ | | | The car park was in good visual condition with spaces accessible to residents. | None |

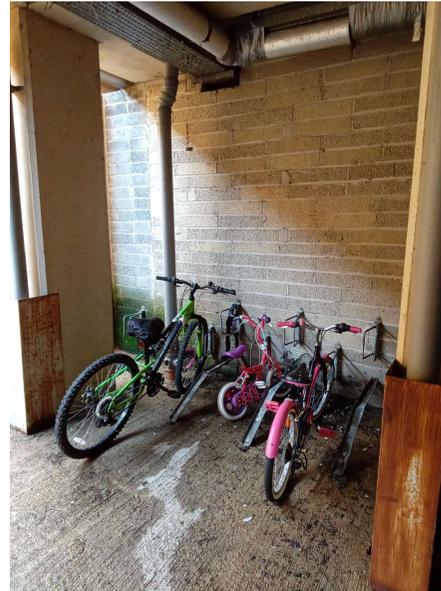
| External Inspection | Acceptable | Not Acceptable | N/A | Comments | Action |
|---|---|---|---|--|---|
| Bike Store (Bicycle Areas) | ✓ | | | The bike store areas are accessible. | None |
