**Company Name:** Cricklade Road Management Company Limited

**Inspection Date:** 14 August 2025

## Purpose

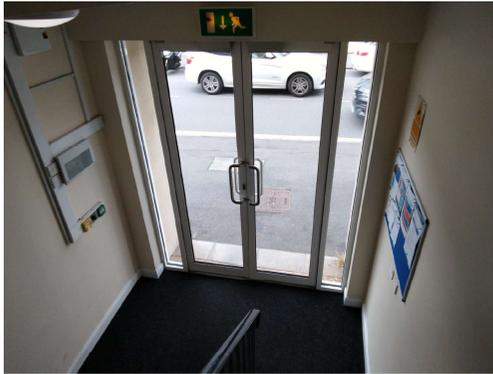
**Entrances (Main Doors)**

Internal Inspection	Acceptable	Not Acceptable	N/A	Comments	Action
<b>Entrances</b> (Main doors)	✓			The magnets on the main entrance door (top of the door) need adjustment. The contractor has been instructed to attend and rectify the issue.	None
<b>Hallway</b> (Communal Lobbies and Stairs)	✓			Hallways and stairs were clean, clear and free from obstructions.	None
<b>Lighting</b> (Standard and Emergency Lighting)	✓			Lighting, including emergency units, is operational with no faults reported.	None
<b>Internal Doors</b> (Compartment Doors)	✓			Doors opened and closed properly.	None
<b>Cupboard Doors</b> (Electrical Cupboard Doors)	✓			Electrical cupboard doors were secured and free from visible damage.	None
<b>Windows</b> (Communal Windows)	✓			Windows in communal areas opened and closed correctly.	None
<b>Signage</b> (Communal Notices)	✓			Building noticeboards was clearly displayed and information was up to date.	None

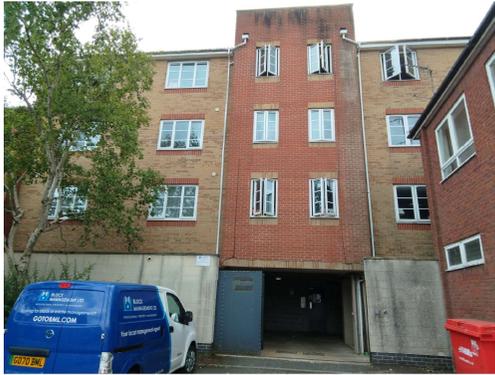
**Exterior Structure (The Building)**

External Inspection	Acceptable	Not Acceptable	N/A	Comments	Action
<b>Exterior Structure</b> (The Building)	✓			Visual inspection of the exterior walls showed no concerns.	None
<b>Guttering</b> (Gutters and Fascia)	✓			Guttering and fascia are intact, with no blockages or damage observed.	None
<b>Roofing</b> (Tiles and Cladding)	✓			Roofing inspected from ground level – no signs of damage noted.	None
<b>Communal Grounds</b> (Gardens and Common Areas)	✓			No concerns observed in communal gardens or pathways.	None
<b>Bin Store</b> (Waste Disposal Areas)		✓		The bin area was found full of house waste like furniture, boxes etc.. The contractor has been instructed to tidy up and collect the waste.	Review
<b>Car Park</b> (Vehicle Parking)				Car park is well-maintained, with no surface damage.	None
<b>Bike Store</b> (Bicycle Areas)					None
<b>Additional Comments</b>					None
