# COMBINED FIRE AND HEALTH & SAFETY RISK ASSESSMENT.

| Address of premises: | Thomas Edward Coard Building<br>Cricklade Road<br>Gorse Hill<br>Swindon<br>SN2 8AB |
| Date of fire risk assessment: | 18 <sup>th</sup> September 2024, Reviewed September 2025 |

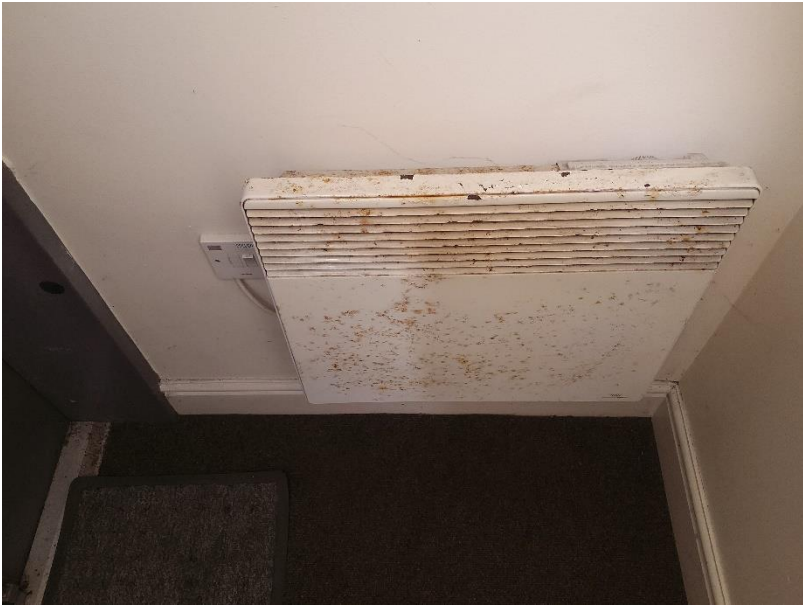
| Item | Recommendation | Priority | Timescale | |
|---|---|---|---|---|
| 03 | The rear staircase is heated by a wall mounted electrical heater, it is recommended that this is inspected and tested by a competent person in line with the fixed electrical installation.<br><br> | 2 | C | Action required<br><br>Unit is disconnected<br>To be removed during redecoration |

| <p>There were no portable heaters identified within the communal areas during this assessment.</p> <p>The rear staircase is heated by a wall mounted electrical heater, it is recommended that this is inspected and tested by a competent person in line with the fixed electrical installation.</p> <p>There is no fixed heating within all other communal areas.</p> | | |

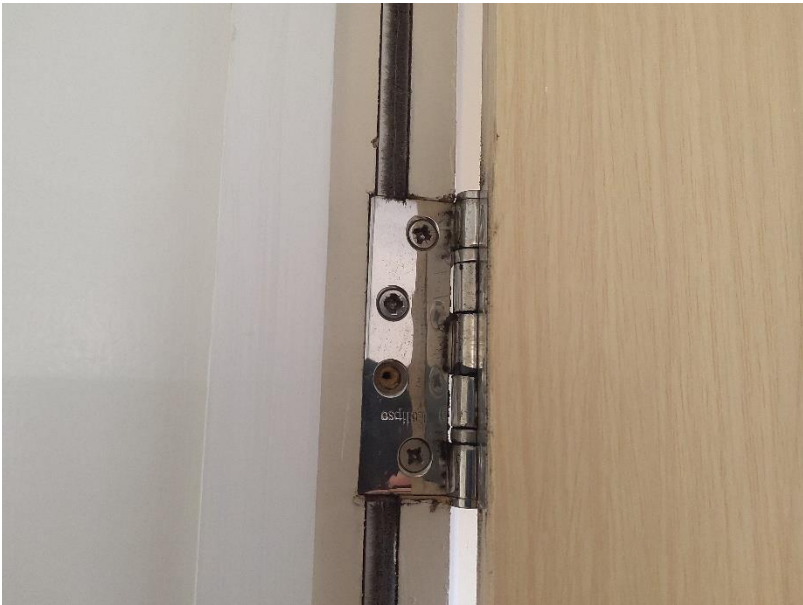
| 06 | <p>It was noted during this fire risk assessment that the 3<sup>rd</sup> floor middle staircase lobby door was missing a screw on the top hinge. It is recommended that the RP instructs a suitably qualified and competent contractor to install a screw which matches the door set in order to maintain the integrity of the door as per Fire Safety (England) Regulations 2022 Fire Door Guidance Section 6.7E.</p> | 3 | B | Action completed |

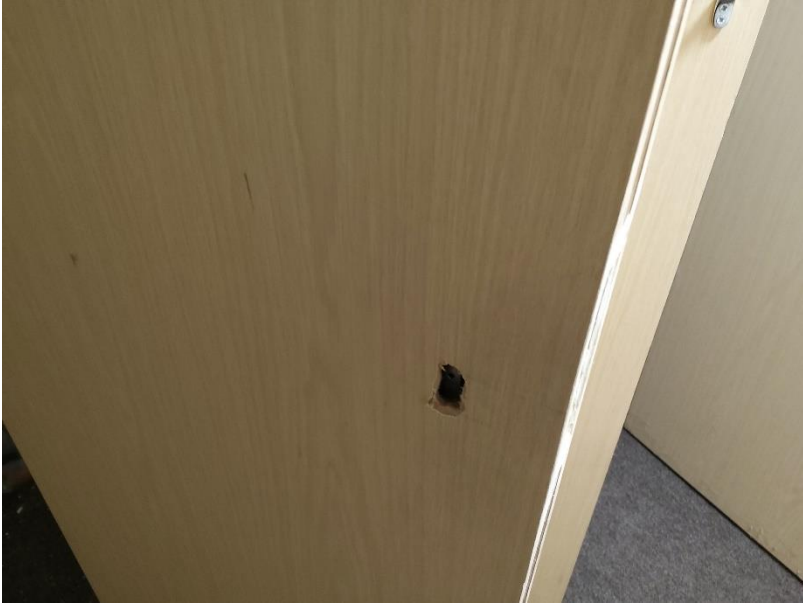
| <p>07</p> | <p>It was noted during this fire risk assessment that there were small keyhole breaches on the internal side of the 3<sup>rd</sup>, 2<sup>nd</sup> and 1<sup>st</sup> floor lift lobby risers. It is recommended that the RP instructs a suitably qualified and competent contractor to repair these breaches with a suitable compound capable of providing a minimum of 30 minutes fire resistance in order to protect the integrity of the fire door as per Fire Safety (England) Regulations 2022 Fire Door Guidance Section 6.7C.</p> | <p>2</p> | <p>B</p> |

Action completed

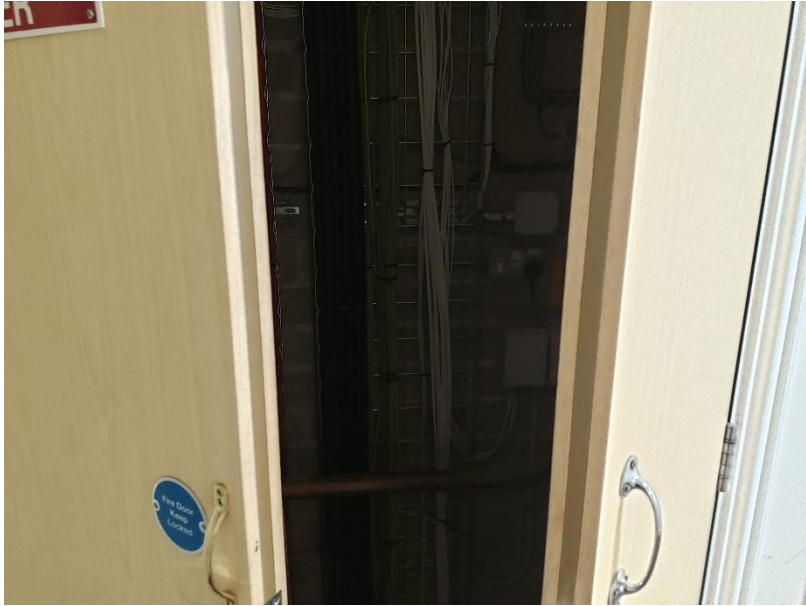
| 08 | <p>It was noted during this fire risk assessment that the cold smoke brush was not present between the lift lobby riser doors on the 3<sup>rd</sup>, 2<sup>nd</sup> and 1<sup>st</sup> floors and at the top of the frame on the left lift lobby riser cupboard on the 1<sup>st</sup> floor. It is recommended that the RP instructs a suitably qualified and competent contractor to install a new cold smoke brush in order to complement the intumescent seal in order to protect the means of escape from cold smoke as per Fire Safety (England) Regulation 2022 Fire Door Guidance Section 6.7F.</p> | 2 | B | Action completed |

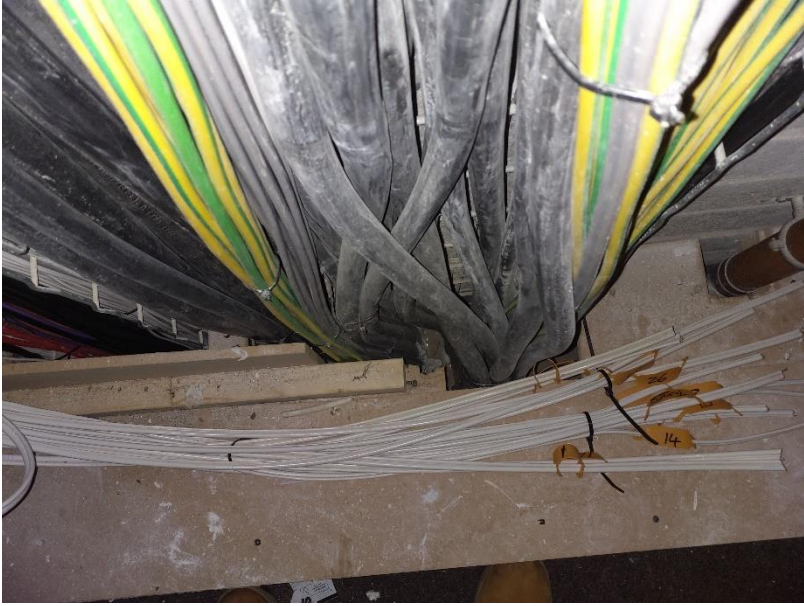
| <p>11</p> | <p>It was noted during this fire risk assessment that the compartmentation within the 1<sup>st</sup> floor lift lobby risers was poor with light shining through the floor which could allow smoke and fire to spread into the means of escape. It is therefore recommended that the RP instructs a suitably qualified and competent contractor to repair these breaches with a compound capable of providing a minimum of 60 minutes fire resistance in order to protect the means of escape.</p> | <p>1</p> | <p>B</p> | <p>Action complete</p> |

| It was noted during this fire risk assessment that the compartmentation within the 1 <sup>st</sup> floor lift lobby risers was poor with light shining through the floor which could allow smoke and fire to spread into the means of escape. It is therefore recommended that the RP instructs a suitably qualified and competent contractor to repair these breaches with a compound capable of providing a minimum of 60 minutes fire resistance in order to protect the means of escape. | | |

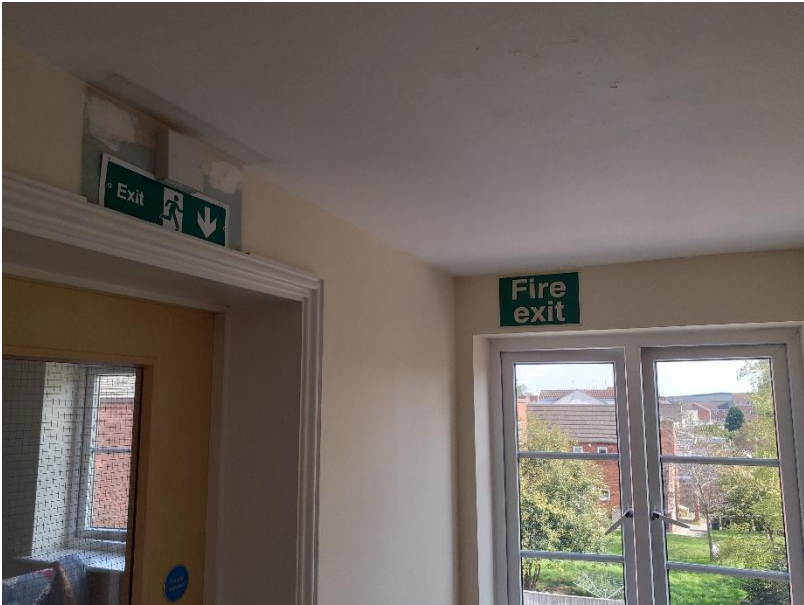
| <p>12</p> | <p>It was noted during this fire risk assessment that the directional signage was inconsistent throughout the premises. It is recommended that the RP instructs a suitably qualified and competent contractor to replace all signage to one design which conforms to safety signs and signals: the health and safety regulations 1996.</p> | <p>2</p> | <p>C</p> | <p>Action required</p> <p>RP to obtain further advice and action as required.</p> <p>Electrician has confirmed that emergency light distance is sufficient to illuminate signage</p> |

| <div>A Fire action notice is installed by each exit door and is completed in full.</div> <div>It was noted during this fire risk assessment that the directional signage was inconsistent throughout the premises. It is recommended that the RP instructs a suitably qualified and competent contractor to replace all signage to one design which conforms to safety signs and signals: the health and safety regulations 1996.</div> | | |
